NBS TECHNICAL NOTE 783

Durability and Maintenance as Related to the Selection of Flooring

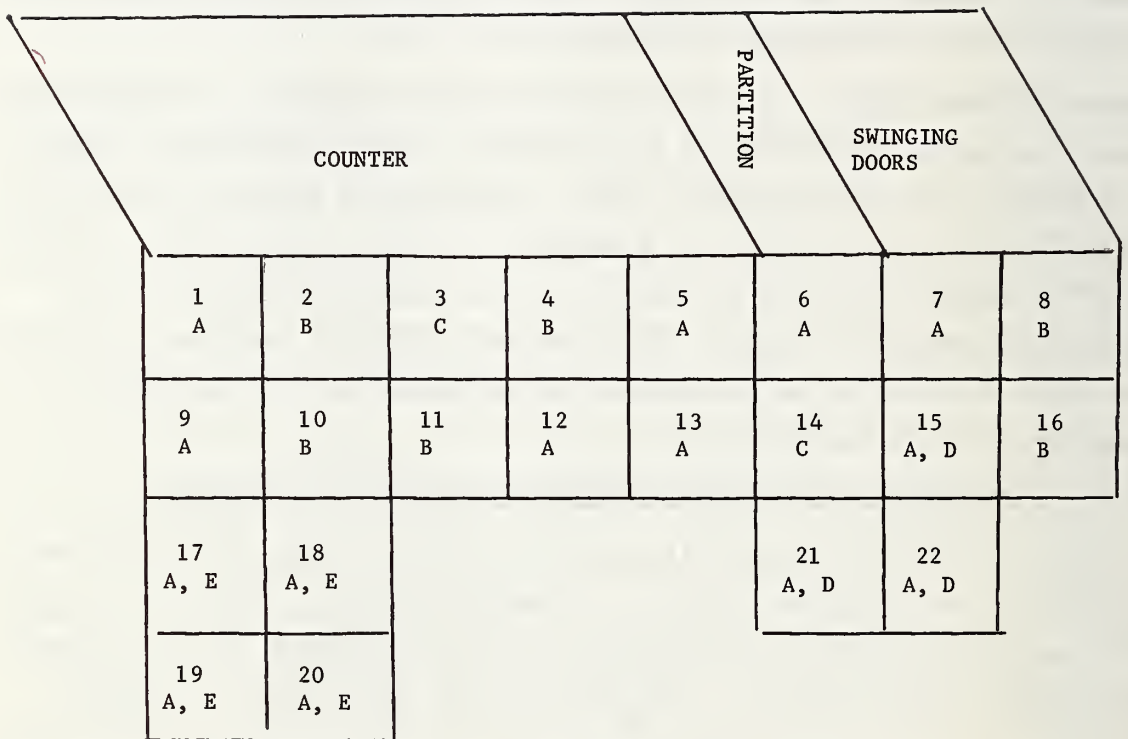
Figure I. Computer Test Area Flooring Layout

A test of resilient floor tiles was performed in front of the counter, partition, and swinging doors of a computer facility. The area behind the counter, partition, and swinging doors is occupied by the equipment and staff of the facility. The test area is illustrated in Figure I.

In Figure I, the access panels covered with test tiles are numbered and the test tiles are indicated by letters A through E. The original tile corresponds to letter A. The 2-foot square access panels, covered with 12-inch square vinyl tiles were installed in May 1967. After two years of service, the tile appeared scratched and scuffed and were somewhat hard to clean. Following is a table of the kinds of resilient tiles used in the test area and the dates of the installation:
